## Watershed Restoration FACTSHEET:

# Sycamore Creek Project

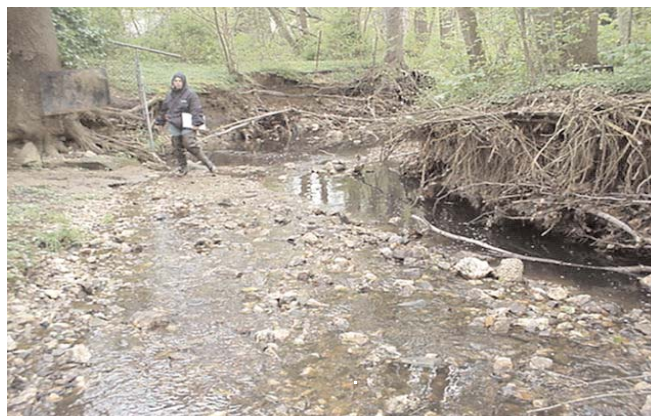
**Pre-restoration conditions included severely eroded stream banks, undercut trees, and limited habitat features**

*The Rock Creek Watershed Feasibility Study* identified several impaired conditions in Sycamore Creek. Uncontrolled stormwater created severe stream bank erosion and unstable banks, undercut trees, and damaged private property. Undercut trees fell into the stream and created debris jams that blocked the stream and caused further bank erosion.

Over time, the stream channel down-cut and became overwidened, which limited

stream flow access to the original floodplain, exposed sewer lines to potential damage, and destroyed habitat necessary for diverse aquatic life. Sediment from eroded banks and road grit accumulated in the stream, further degrading stream habitat conditions.

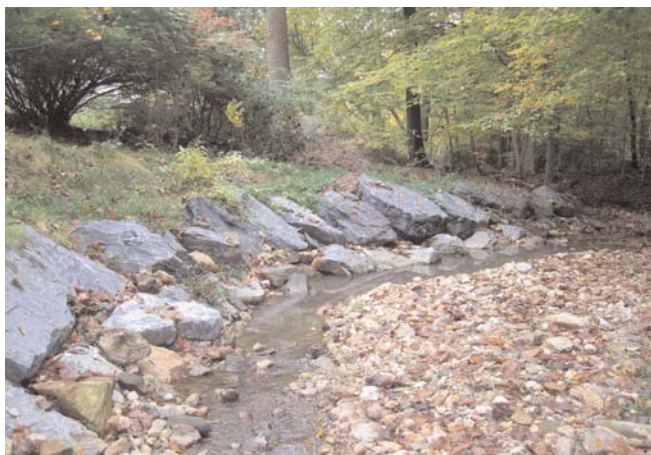
**Boulder rock stabilizes the toe of a stream bank slope. Native riparian trees and shrubs planted above the rock provide long-term stream bank stability.**

Boulder rock installed at the toe of stream bank slopes stabilized the area of the stream channel subject to the greatest erosive, or "shear", stress. The slopes above the reinforced toes were graded back to create new floodplain terraces, and planted with native trees and shrubs to further stabilize the stream banks.

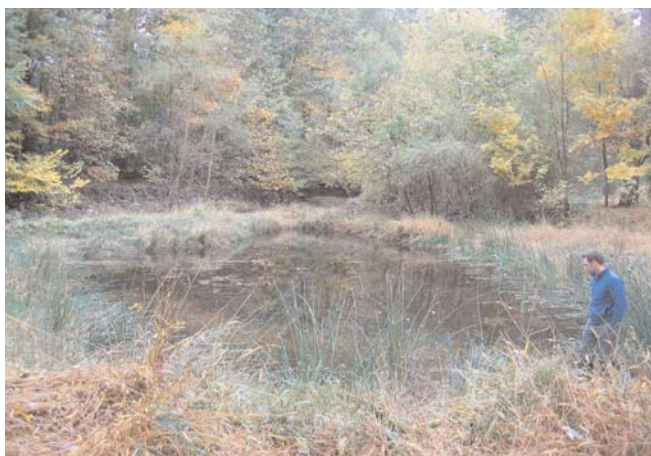
**Shallow wetlands constructed to treat stormwater runoff quality also created valuable habitat for aquatic plants, insects and animals.**

Two shallow wetlands were created to treat water quality of stormwater discharges from two local storm drains. These wetlands quickly establish balanced aquatic communities, which add additional aesthetic and habitat benefits, including natural mosquito control.

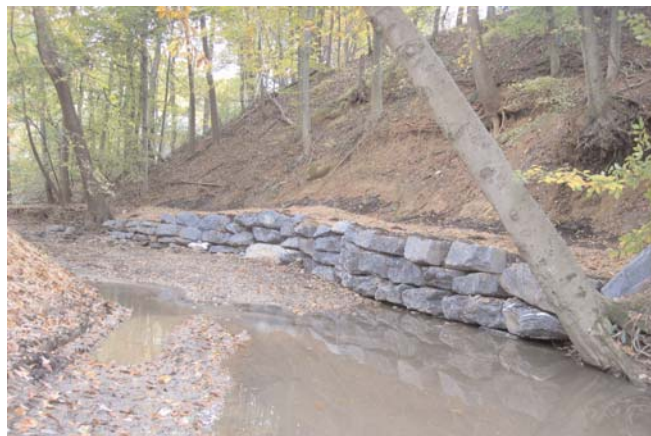
**Imbricated rock wall protects the toe of a steep slope. A constructed terrace on top of the wall provides an area for additional plantings**
